Vehicle Specific Clutch Kit Installation Notes

TBC23

The following kit numbers R379N, R1076N, R1136N, R1137N and R1112N

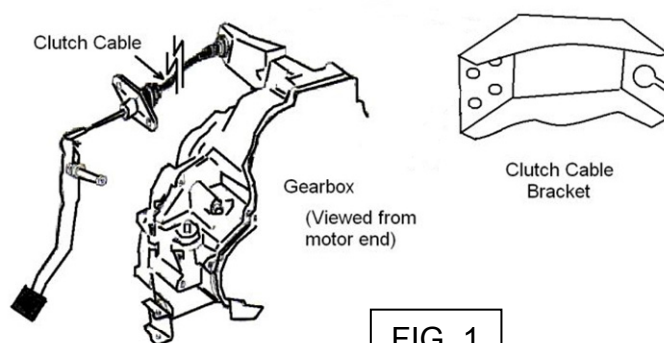
FIG. 1

Excessive Free Travel & Clutch Non-Release

The actuation system may have worn or the clutch pedal support may be deformed to the point where it cannot actuate the clutch. (Fig 1)

Check for indications of deformed supports and for worn components i.e.

- Excessive firewall flexing or cracking.
- Excessive Cable Bracket flexing or Cracking.
- Bearing nose cone slide wear – front of gearbox.

Repair or replace worn or cracked parts

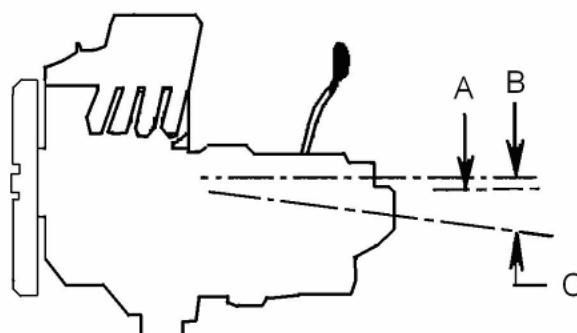
FIG. 2

Premature Clutch Failure Caused By Misalignment (Fig-2)

The tin plate located between the motor and gearbox surfaces can be overlooked or improperly located during installation. If so it may interfere in the correct alignment of the drive train, loads on the clutch components will be uneven and damage of side plate, springs and hub will occur. The clutch will slip and ultimately fail prematurely. ***The tin plate located between the motor and the gearbox surfaces must be cleaned and aligned perfectly on the dowel pins and bolts when mating gearbox to motor.***
